A Lake and Watershed

Management Plan

Koshlong Lake

(Commemorating the KLA 50th Anniversary)

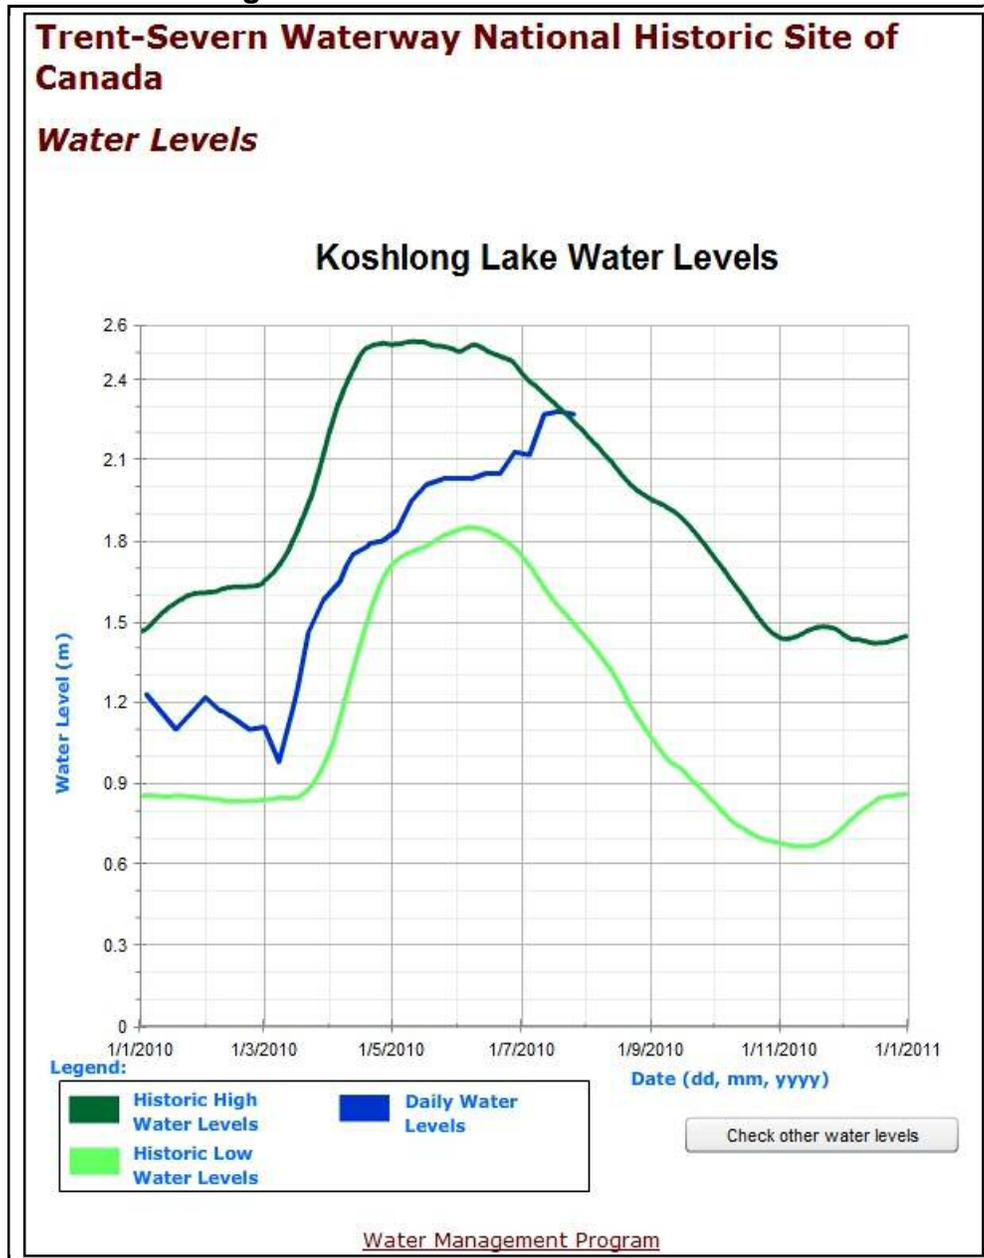
Figure 3.3 – Year-to-Date Water Levels

Graph is Courtesy of Parks Canada – 28 July 2010

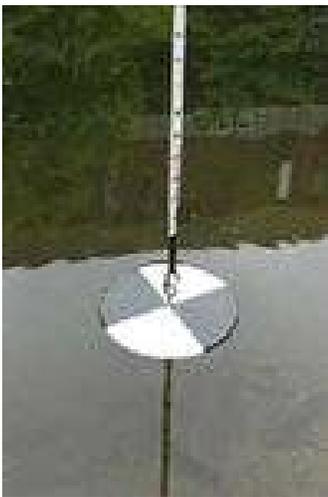
Water Clarity – Secchi Disk

Water clarity is a widely accepted indicator of lake trophic status. Secchi disks (*a 20 cm in diameter, black and white disc, which is lowered into the water by a rope marked in 1 m increments to determine the depth to which light penetrates the water column*) are the most inexpensive, common and effective tools used to measure the level of turbidity or water clarity. The common assumption is that the deeper the Secchi disk reading, the clearer and more oligotrophic the lake.

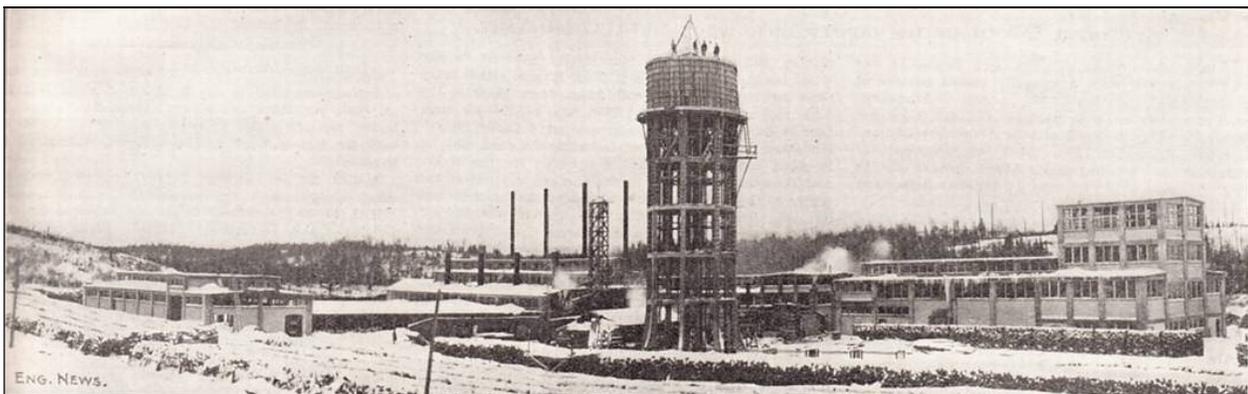
In order to be prosperous, a charcoal kiln needed three elements – an abundant supply of hardwood, a water supply (for the wood distillation process) and a railway (to transport its products). These were all available in Haliburton area.

Figure D1 - Under Construction - Courtesy of an article in Engineering News – January 28th, 1909

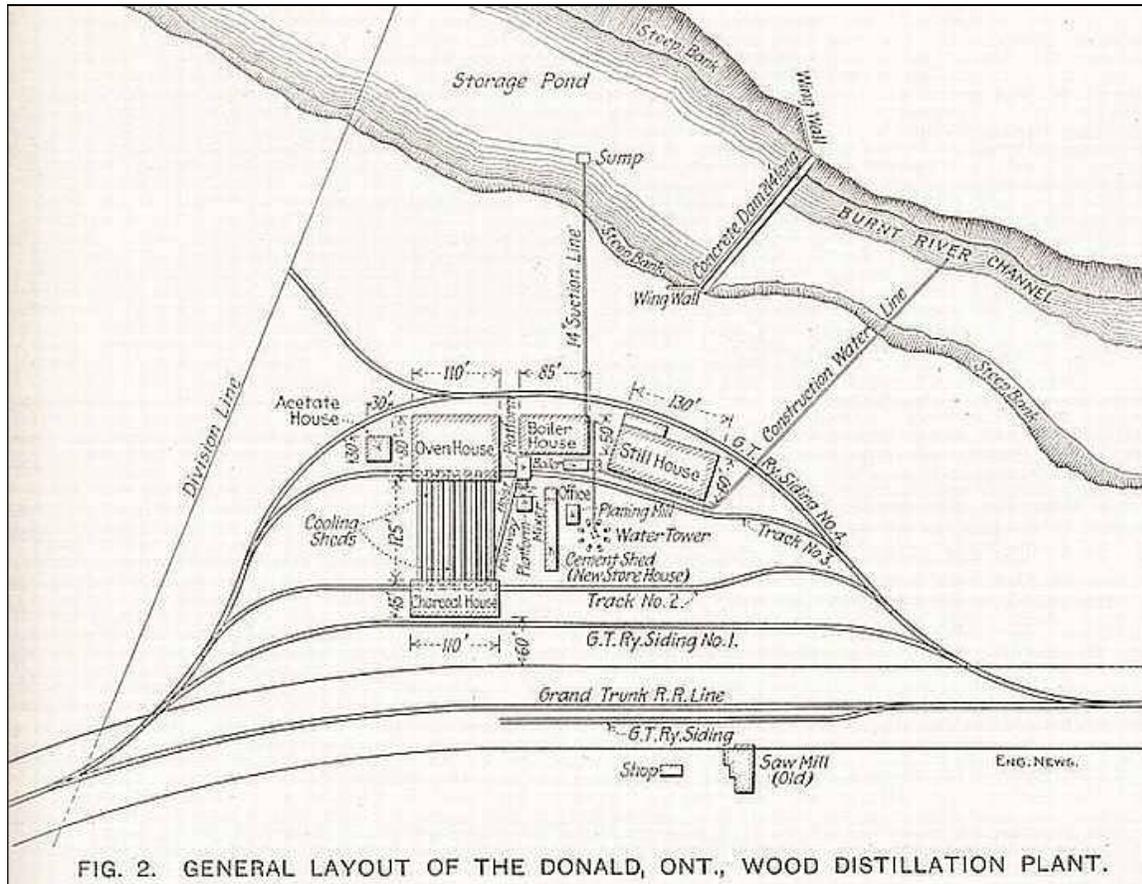
Figure D2 - Courtesy of an article in Engineering News – January 28th, 1909

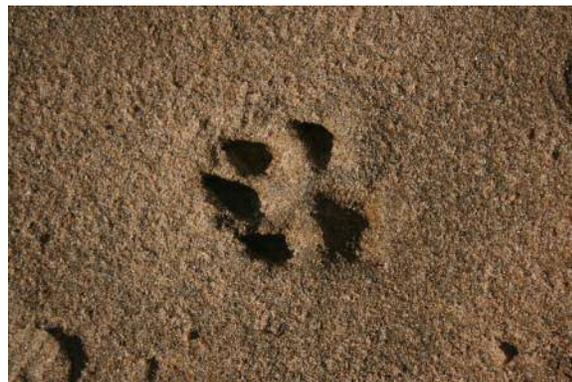
Figure 1: Gray Fox Track in the sand

was a perfect spot to have any sort of track findings due to the grounds soft surface that can give evidence of mammals or birds presence. Due to the recent moose hunting season, the shoreline of the lake was to be used instead of doing analysis in the forest itself. Several tracks were found out on the sandy shores and muddy areas around the lakes perimeter. They consisted of mostly canids (Domestic dogs, Grey Fox), White-tailed deer, and the odd raccoon, beaver, and fisher tracks were found. In some spots the there were more the one deer track suggesting that there were possibly a doe with her fawn close by. Most of the tracks recorded were approximately between one to two days old.

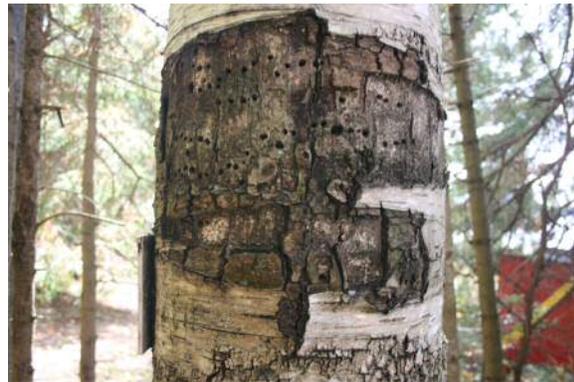
Figure 2: Woodpecker holes in a White

While tracks were being determined and recorded, several other wildlife signs had come to attention. Markings on birch trees and Eastern Hemlock that were made by either different types of woodpecker or even a form a sapsucker but cannot be identified for sure. These markings in the bark of these trees were possibly made for these woodpeckers or sapsuckers trying to get food from the grubs or other insects that live more in the depth of the tree. A possible den site and beaver dam were also observed. The den site could have possibly belonged to a fisher that is within the area that was being observed. Evidence of this was fisher tracks leading back and forth from the den site. A beaver dam site was also observed during the duration of this field placement. Obvious beaver tracks made in the mud around the dam site as well as piles of stick and other woody debris making this dam.

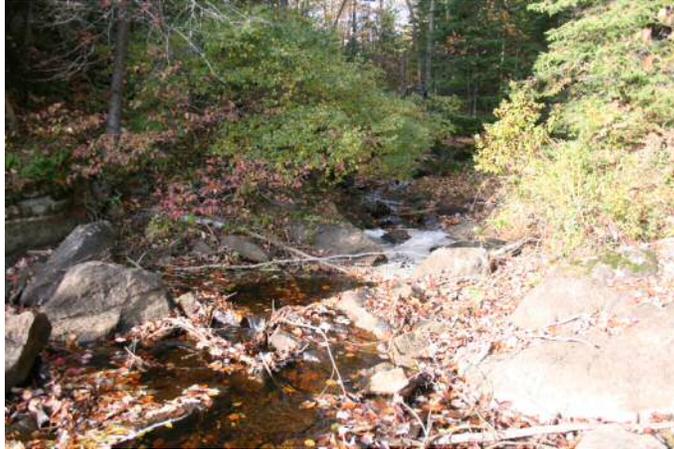
Figure 3: An average tributary creek of

There are 15 different tributaries found to contribute water to Koshlong Lake. The tributaries were counted using a direct count method. There are many different sources for the water that enters the lake; the sources include other lakes, wetlands, and groundwater sources. The geographic coordinates of the tributaries were recorded so that at a later date the

chemistry of the water entering the lake can be tested and monitored. Most of the tributaries were creeks of varying sizes and shapes but determining the location of the inlet was difficult. The water level in Koshlong Lake for the fall of 2009 was very low; this means that the entrance of the tributaries will be different at different points of the year. The ground water sources that contribute to the lake appear to

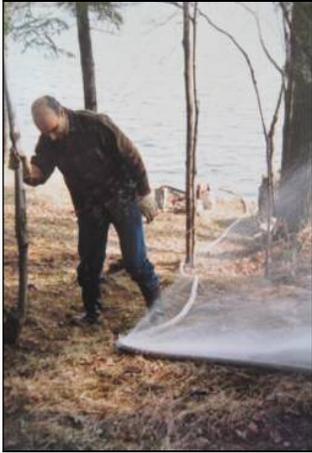
Splits in Hose

One fire in April 1984 was particularly notable. Not just because it decimated the main cottage at lot #58 (1820 Koshlong Lake Road), but rather that it pointed out the poor condition of firefighting equipment. There was only one serviceable pump on the lake and the hoses were in dire condition. Each hose had so many splits that more water came out of those holes than flowed through the nozzle. When it was over, all that was left of the cottage was the stone chimney. The cause of that fire was a lightning strike that travelled down the main hydro wires, through a fuse panel and out a socket that was near a basket of papers. Those papers caught fire and the fire roared inside until a neighbour noticed it. Fortunately, no one was in the cottage at the time.
