Koshlong Lake Shoreline Assessment Summary Report

June 2015

Submitted to the Koshlong Lake Association by Watersheds Canada

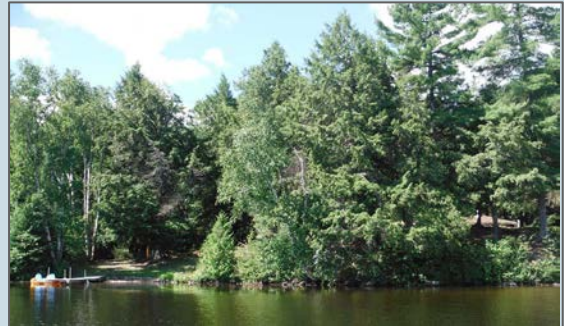
Natural – A healthy buffer of vegetation and/or a natural shoreline of sand or exposed rock that is undisturbed and undeveloped.

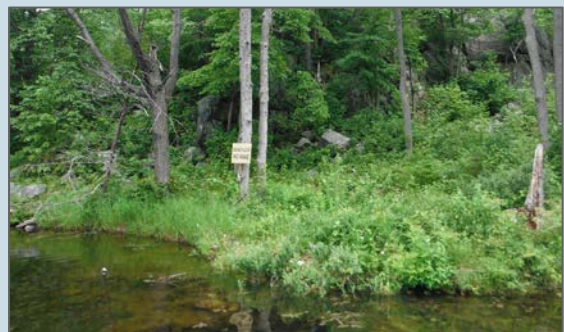
Regenerative – Natural vegetation has been removed in the past, but is in the process of growing back towards a natural state.

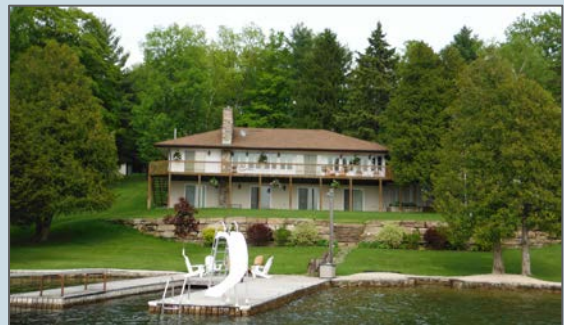
Ornamental – All natural vegetation has been removed and replaced with mowed lawn and other non-native vegetation; structures such as docks, decks, boathouses and boat ramps are predominantly present at the shore.

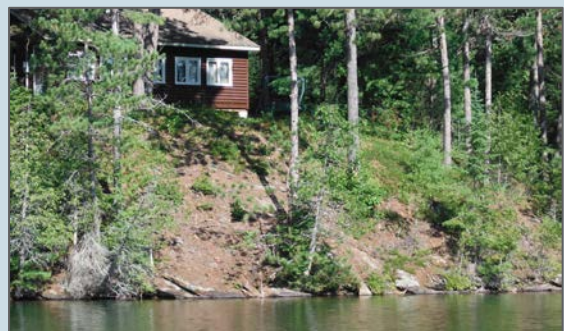
Degraded – Natural vegetation has been lost; soil erosion, undercutting of the bank, and/or exposed roots of shrubs and trees are significant.

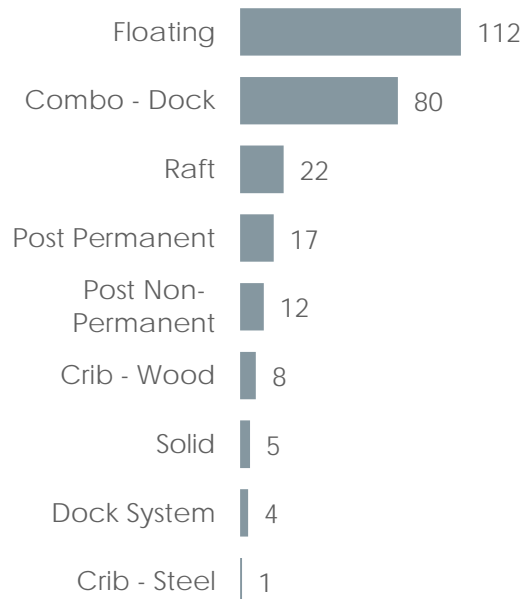
Figure 6 Docks on Lake

Small floating or post non-permanent docks are the best choice of docks as they have minimal contact with the lake bottom, and sit on or out of the water, which reduces the impact they have on the surrounding environment. In the future, if shoreline property owners need to replace their old or failing permanent post, solid, or crib docks, they could consider a non-permanent post dock or floating dock, thereby limiting impacts to fish habitat and ensuring the natural flow of water remains unrestricted.

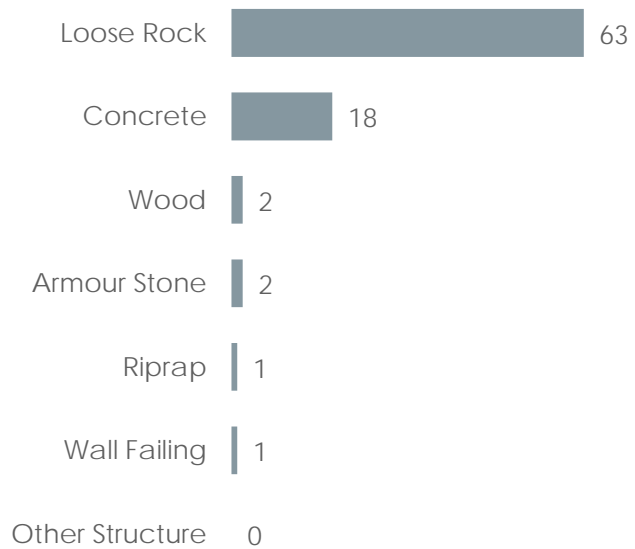
Figure 7 Retaining Walls on Lake

On Koshlong Lake, the number of properties with retaining walls was counted and summarized below. Retaining walls, most often built to protect against erosion are a common feature on many lakes. 34% of properties had retaining walls present. The types and frequency of retaining walls is below in figure 7:

87 properties on Koshlong Lake, or 34% of properties assessed, have a retaining wall. Of the retaining walls that are present the most common choice was loose rock (63 properties or 25% of properties assessed), followed by concrete (18 properties or 7% of properties assessed). While retaining walls were a common choice in the past to combat erosion, we now know about their impact to the natural environment. Waves and wakes are reflected back from flat, hard surfaces with the same force as they strike the wall. This can cause excess turbulence in the water, which scours the sediments from the lake bottom. Solid walls also eliminate shoreline habitat and act as a barrier, preventing wildlife from reaching the water. Although some retaining walls such as rip rap or loose rock have fewer impacts than other retaining walls, shoreline property owners could consider alternative erosion control methods such as planting vegetated buffers or shoreline bioengineering if they ever wish to replace their current, old, or failing retaining wall. In the meantime, maintaining vegetation around the wall and allowing new vegetation to establish and grow will help reduce runoff and provide habitat for wildlife.

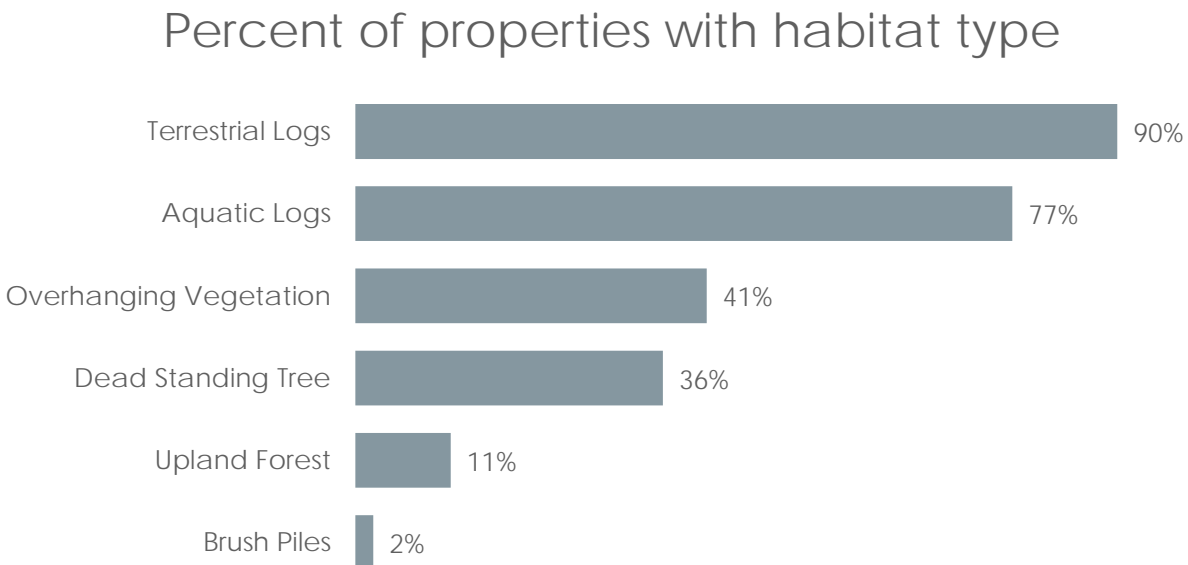
Figure 10 Habitat Present

Most common types of nearshore habitat on Koshlong Lake were terrestrial logs, followed by aquatic logs. Most properties on Koshlong Lake had some amount of habitat present. Wildlife provides us with many enjoyable and beneficial activities from bird watching and wildlife photography to pest control, seed dispersal, nutrient cycling and pollination, to name just a few. It is important for there to be a rich and diverse range of habitats along the lakeshore to ensure a healthy lake environment. Figure 10 summarizes the lake nearshore habitat.

It is important to leave large trees that are dead and dying in place, as they provide important habitat for a number of different species. In Ontario, more than 50 species of birds and mammals depend on cavity trees for nesting, rearing young, roosting, feeding, storing food, escaping predators, and hibernating. Fallen logs on land provide habitat for small mammals such as moles, woodpeckers, toads and insects. As the log decomposes, reptiles and amphibians lay their eggs in the moist wood. A decaying log is also great habitat for beetles, and ants that burrow under the bark and lay eggs. In the water, logs provide important fish habitat by providing
